Property Inspection Report

Phone: 616-000-0000
1234sample.org
Date of Inspection: June 1 2006
Time: 8:30 am
Weather Conditions: 76 / sunny

sample report
USA Ville, N/A 00000

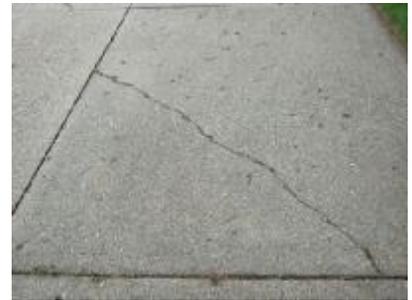
- There are large cracks in the driveway.
- There are uneven spots on the driveway.

Seven of the concrete slabs in the drive show cracks. Driveway is what one would expect for the age. The driveway has trip hazards.

Two 4'x8' slabs closest to the Garage door on the exterior side, requires leveling OR replacement!

NOTE: Result is a poor-non positive seal at the bottom of the garage door to the concrete surface; abnormal settlement was observed for the driveway at the roll up garage door. This area is a trip hazard.

You should consult a licensed contractor about the needed repairs.

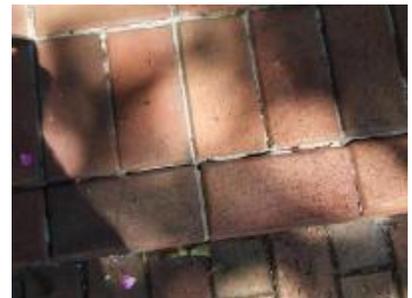
Steps To Building

- The steps show signs of deterioration.
- The steps are settling away from the house

The steps have an uneven rise or spacing. Cracks in bricks or mortar are in need of repair.

This is a >SAFTEY CONCERN< Do not use front entry until repairs have been made.

You should consult a licensed contractor about the needed repairs.

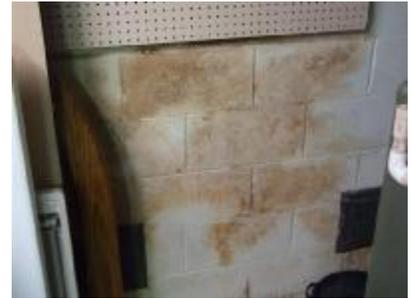
Foundation

- There are signs of water penetration or condensation problems.
- There is efflorescence present indicating water damage.

Past, water penetration in the basement under the chimney area was observed, Note: DRY today. This appears to be from the deteriorated exterior chimney brick and mortar problem. SEE Chimney section! **Attention is needed ASAP** to prevent further deterioration.

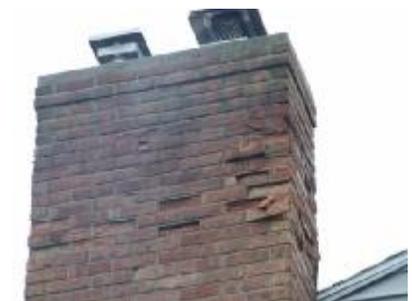
Chimney(s)

- The chimney is missing bricks or flashing.

Severe spalling of bricks is viewable! This chimney needs to be re built. (tuck pointing is not an option. You should consult a licensed contractor about the needed repairs. **Falling debris is a safety factor here.** Area should be roped off ASAP and A/C condenser be protected from falling debris.

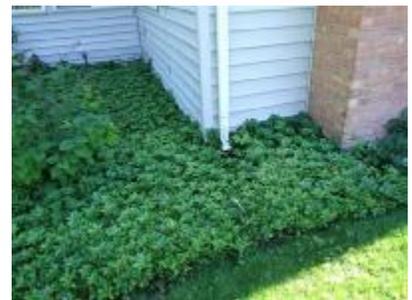
Gutters & Downspouts

Gutter extensions recommended on left elevation of house, with appropriate splash blocks.

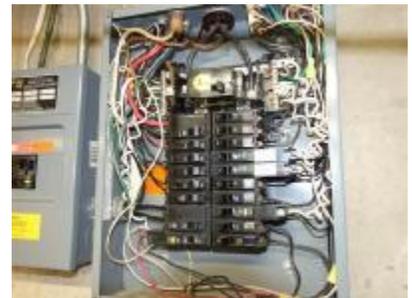
Main Panel

Circuits are not "all" labeled in service panel. including sub panel
Suggested is an upgrade to panel to 125 amp or higher service, This panel has no room for expansion! You should consult a licensed contractor about the needed repairs.

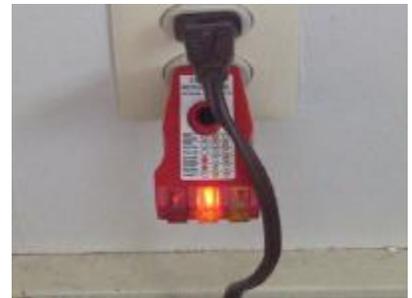
Outlets, Fixtures, & Switches

Living room west wall (3) and (1) plug on North wall are ungrounded
(1) at bottom of stair well has reversed polarity.
Exterior electrical circuit at right rear if family room , the one up high is a non functioning circuit (no power),
Possibly just remove this outlet! You should consult a licensed contractor about the needed repairs.

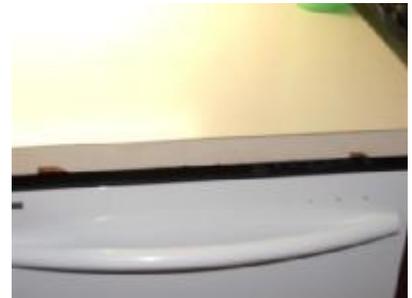
-The counter tops are scratched or damaged.

The countertops show some damage. Chips at and near dish washer. Tops are in relatively good shape showing some imperfections, and what one could expect for their age.

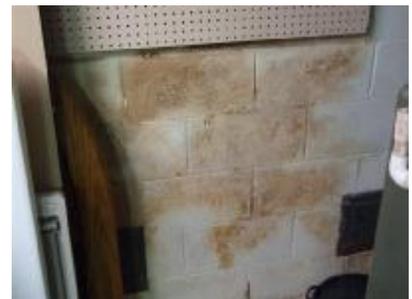
Comments:
Water seepage signs under the Chimney/fireplace. See notes there.
also the notes under the gutter section.

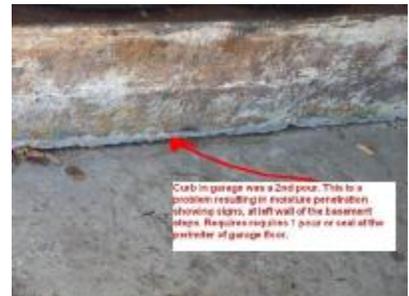
Problems:
-There are large cracks in the floor.

Comments:
The Garage floor curb appears to be a second pour (not a single pour with the floor) This may result in water seepage to the basement wall adjacent to this area. This will result in loss of paint on this wall, and contribute to moisture in the basement during the winter months as the ice and snow melts off of the autos in the garage space.

Recommend when replacing garage floor, have a drain installed in the floor. or just seal the curb to the existing concrete floor. You should consult a licensed contractor about the needed repairs.

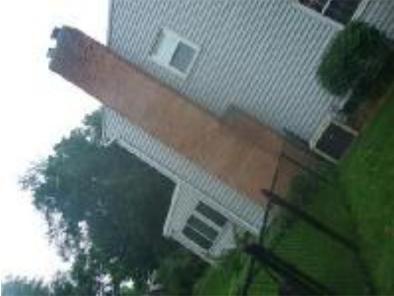
1 Excessive spalling

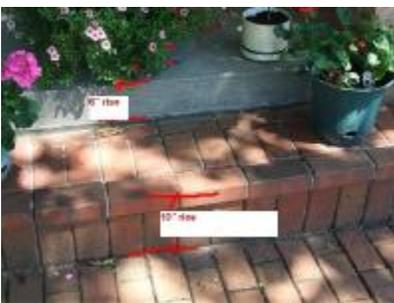
2 Un even riser step height

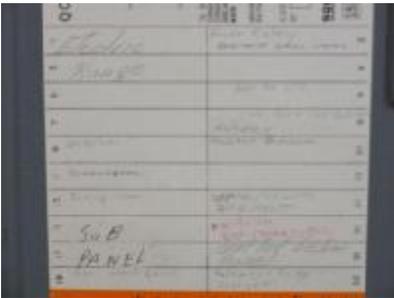
3 Partially unlabeled electrical panel roster

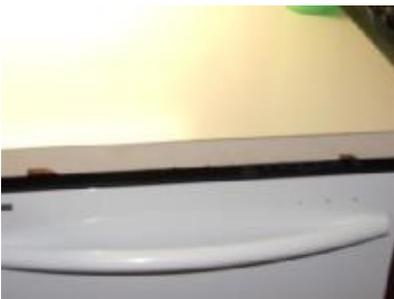
4 Laminate chips

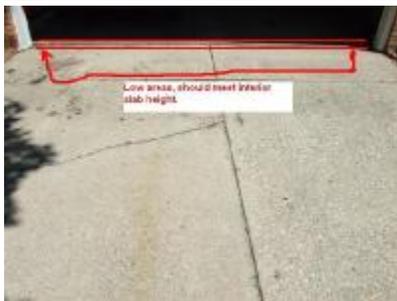
8 Garage door no positive seal

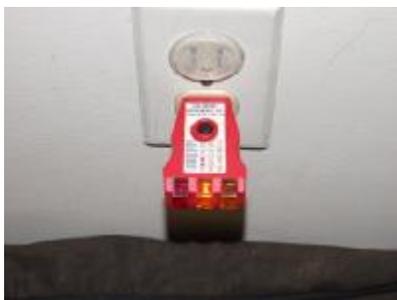
9 open ground

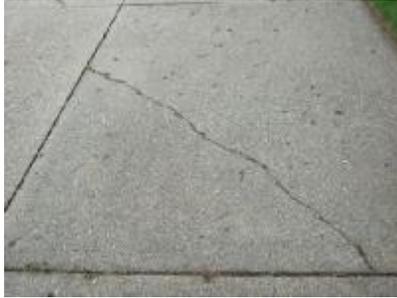
10 sample of drive surface

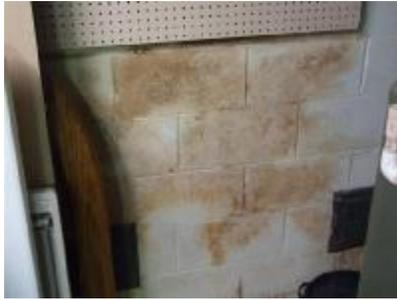
11 view of moisture penetration under chimney
