Property Inspection Report

Phone: 616-000-0000
1234sample.org
Date of Inspection: June 1 2006
Time: 8:30 am
Weather Conditions: 76 / sunny

sample report
USA Ville, N/A 00000

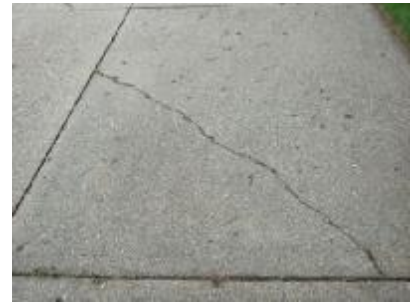
- There are large cracks in the driveway.
- There are uneven spots on the driveway.

Seven of the concrete slabs in the drive show cracks. Driveway is what one would expect for the age. The driveway has trip hazards.

Two 4'x8' slabs closest to the Garage door on the exterior side, requires leveling OR replacement!

NOTE: Result is a poor-non positive seal at the bottom of the garage door to the concrete surface; abnormal settlement was observed for the driveway at the roll up garage door. This area is a trip hazard.

You should consult a licensed contractor about the needed repairs.

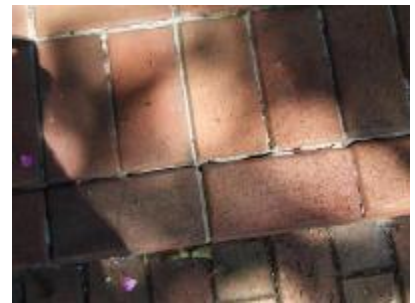
Steps To Building

- The steps show signs of deterioration.
- The steps are settling away from the house

The steps have an uneven rise or spacing. Cracks in bricks or mortar are in need of repair.

This is a >SAFTEY CONCERN< Do not use front entry until repairs have been made.

You should consult a licensed contractor about the needed repairs.

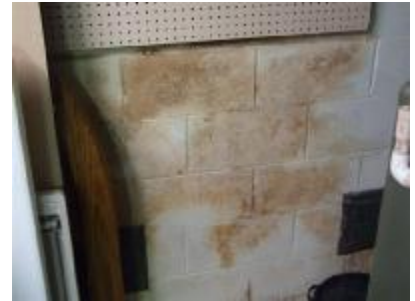
Foundation

- There are signs of water penetration or condensation problems.
- There is efflorescence present indicating water damage.

Past, water penetration in the basement under the chimney area was observed, Note: DRY today. This appears to be from the deteriorated exterior chimney brick and mortar problem. SEE Chimney section! **Attention is needed ASAP** to prevent further deterioration.

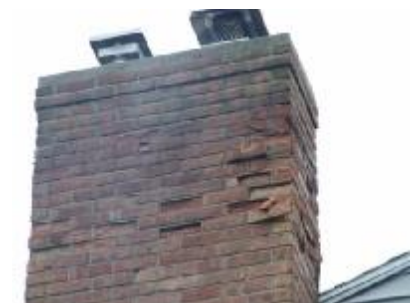
Chimney(s)

- The chimney is missing bricks or flashing.

Severe spalling of bricks is viewable! This chimney needs to be re built. (tuck pointing is not an option. You should consult a licensed contractor about the needed repairs. **Falling debris is a safety factor here.** Area should be roped off ASAP and A/C condenser be protected from falling debris.

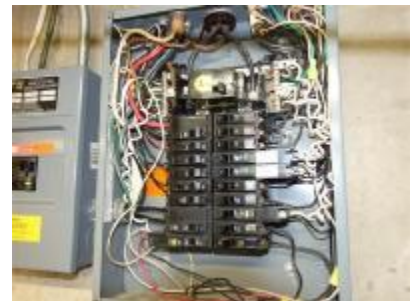
Main Panel

Circuits are not "all" labeled in service panel. including sub panel
Suggested is an upgrade to panel to 125 amp or higher service, This panel has no room for expansion! You should consult a licensed contractor about the needed repairs.

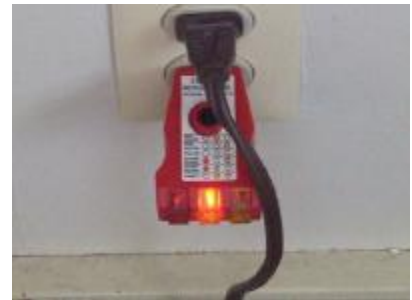
Outlets, Fixtures, & Switches

Living room west wall (3) and (1) plug on North wall are ungrounded
(1) at bottom of stair well has reversed polarity.
Exterior electrical circuit at right rear if family room , the one up high is a non functioning circuit (no power),
Possibly just remove this outlet! You should consult a licensed contractor about the needed repairs.

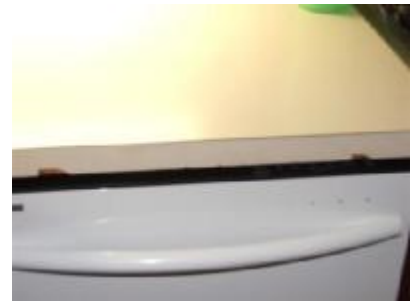
-The counter tops are scratched or damaged.

The countertops show some damage. Chips at and near dish washer. Tops are in relatively good shape showing some imperfections, and what one could expect for their age.

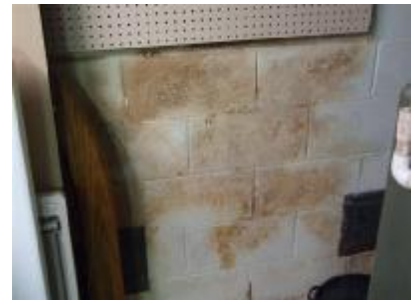
Comments:
Water seepage signs under the Chimney/fireplace. See notes there.
also the notes under the gutter section.

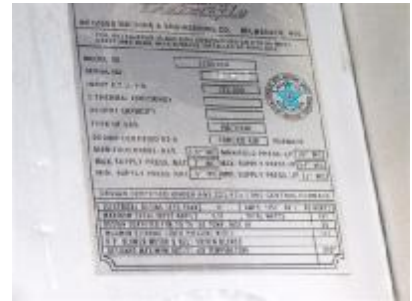
Old / and inefficient,

at least a good duct cleaning as well as the burner cleaning.

Replace filter annually.

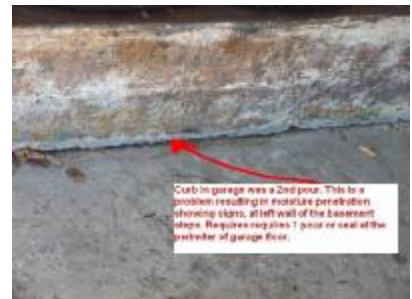
Problems:
-There are large cracks in the floor.

Comments:
The Garage floor curb appears to be a second pour (not a single pour with the floor) This may result in water seepage to the basement wall adjacent to this area. This will result in loss of paint on this wall, and contribute to moisture in the basement during the winter months as the ice and snow melts off of the autos in the garage space.

Recommend when replacing garage floor, have a drain installed in the floor. or just seal the curb to the existing concrete floor. You should consult a licensed contractor about the needed repairs.

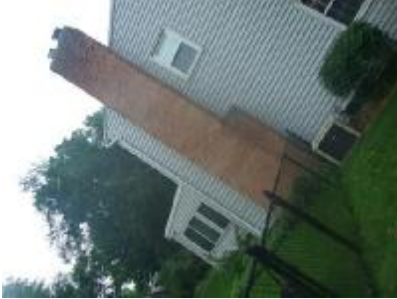
1 Excessive spalling

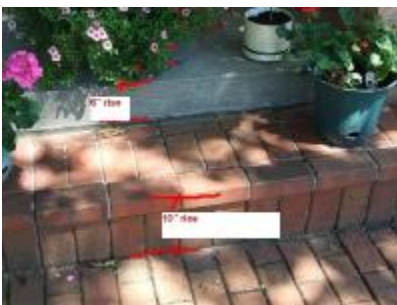
2 Un even riser step height

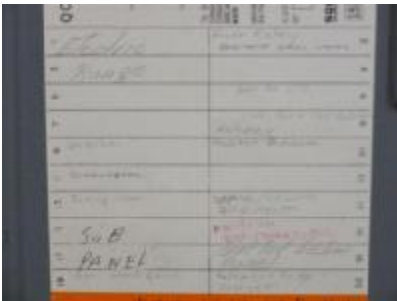
3 Partially unlabeled electrical panel roster

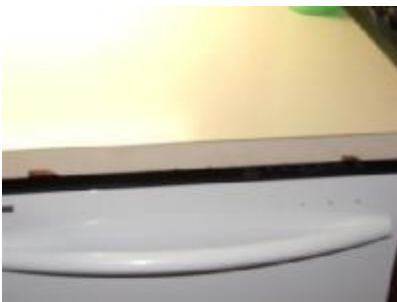
4 Laminate chips

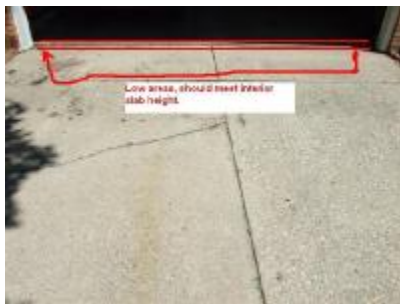
8 Garage door no positive seal

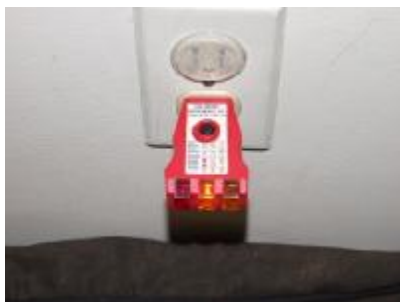
9 open ground

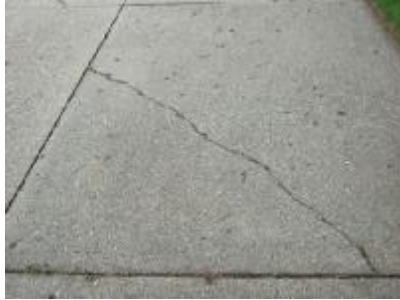
10 sample of drive surface

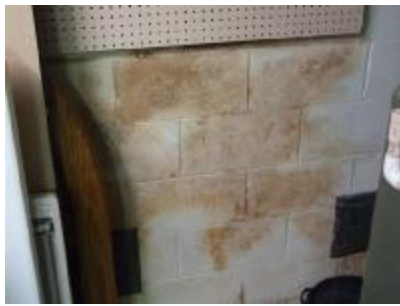
11 view of moisture penetration under chimney
